| 4. Title and Subtitle<br>ROLLING ELEMENT FATIGUE TESTING OF GEAR MATERIALS | | 5. Report Date<br>April 1978 | |
| 7. Author(s)<br>A.H. Nahn | | 8. Performing Organization Report No.<br>R78AEG289 | |
| 9. Performing Organization Name and Address<br>Material & Process Technology Laboratories<br>Aircraft Engine Group<br>General Electric Company<br>Cincinnati, Ohio 45215 | | 10. Work Unit No. | |

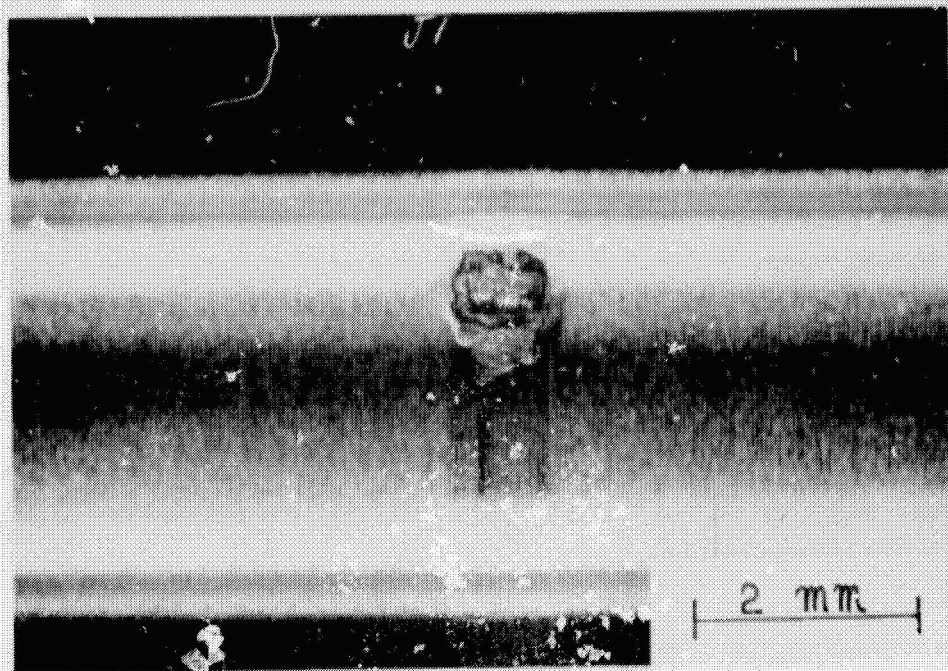
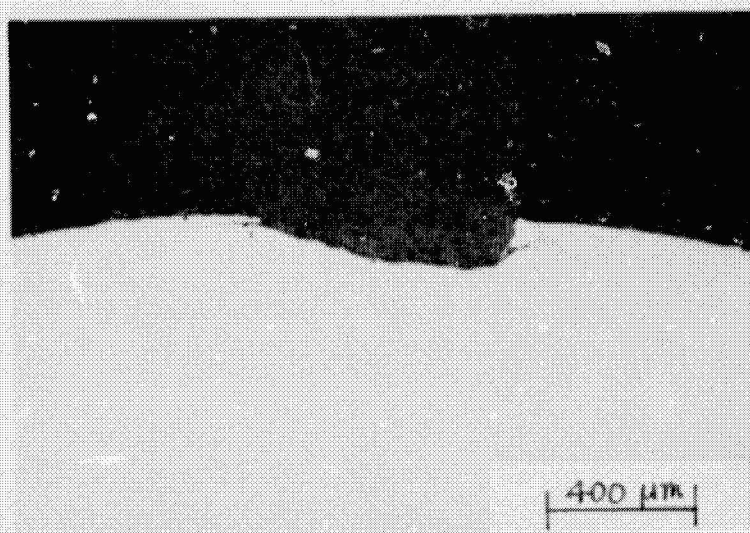
Failure mode observed in RCF testing was of classical subsurface initiated fatigue spalling or pitting, characteristic of that observed in bearings and gears. A rolling fatigue failure of CRS 600 is shown in Figure 3 as an example.

Figure 3. Typical Rolling Contact Fatigue Failure in CBS 600.

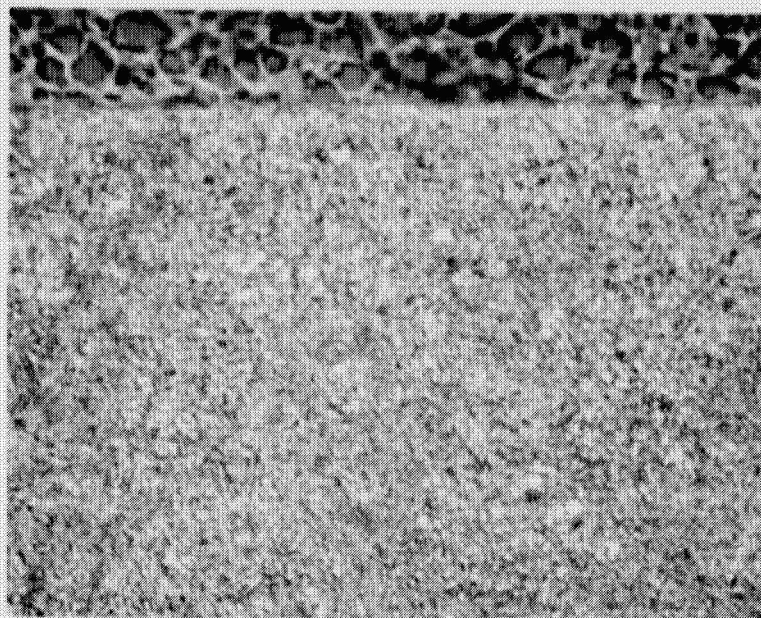
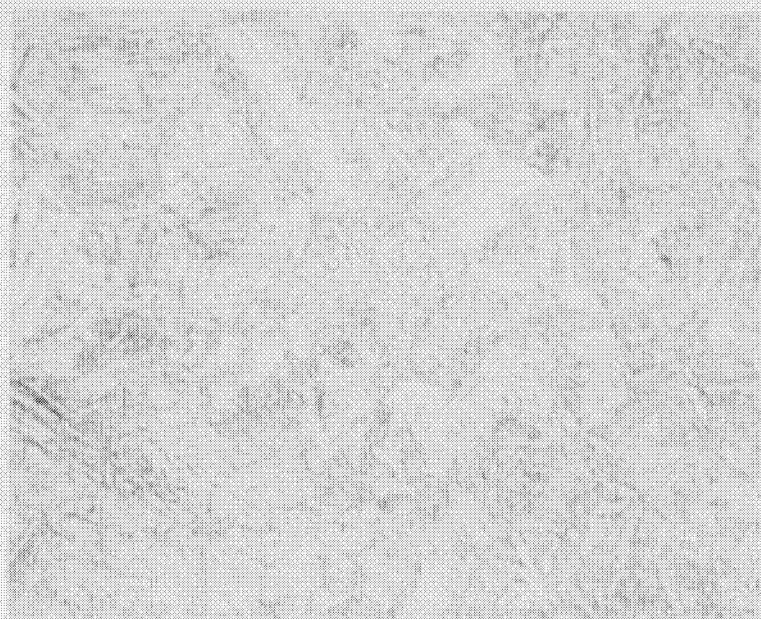
Optical photomicrographs showing case and core microstructures of Test Series x and AA are given in Figures 6 and 7. No noticeable differences in optical microstructure were found between VIM-VAR AISI 9310 (Test Series AA) and VAR AISI 9310 (baseline). Figure 6-(a) clearly shows that high retained austenite is present in the case microstructure of Test Series x specimens (compare with Figure 7-(a)). The retained austenite is seen as unetched white background phase. A summary of metallurgical analysis of AISI 9310 test series is given in Table 4. Variations of the amount of retained austenite present in the case structure were measured to be 8.3%, 11.2% and 20.1% for Test Series AA, baseline, and x respectively. Retained austenite and melting process seem to be the only significant variables influencing rolling contact fatigue life behavior of AISI 9310 under the present experimental conditions (see Table 4). Differences among all the other important variables, for example, hardness, effective case depth, etc., are minimal.

Figure 6. Optical Microstructure of AISI 9310, Test Series X.

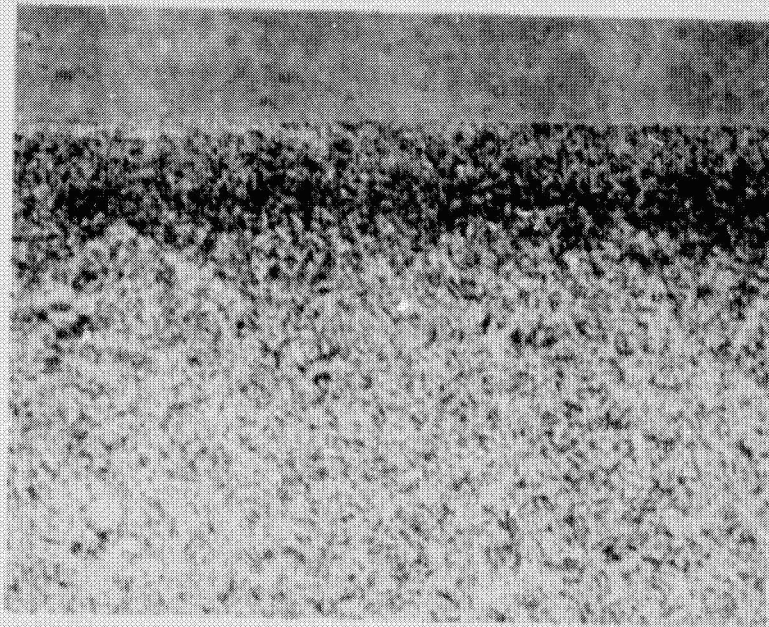
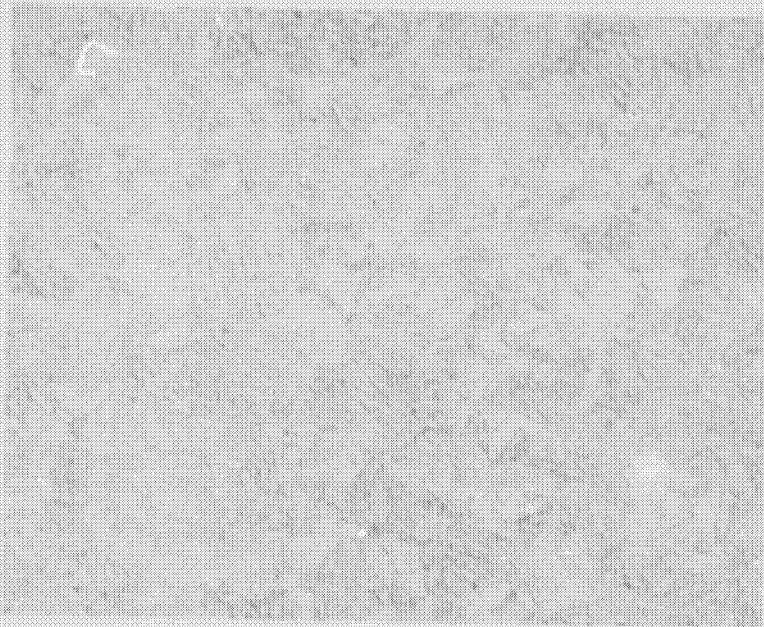
Figure 7. Optical Microstructure of AISI 9310, Test Series AA.

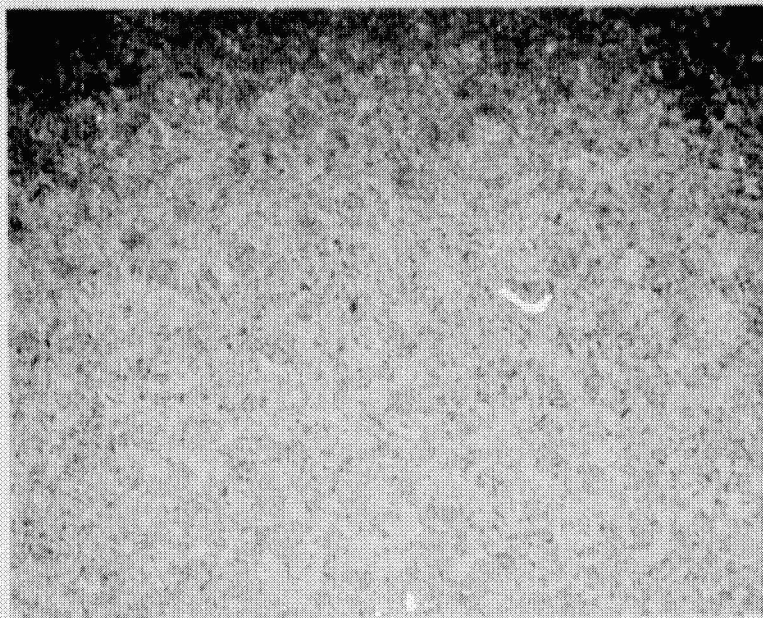
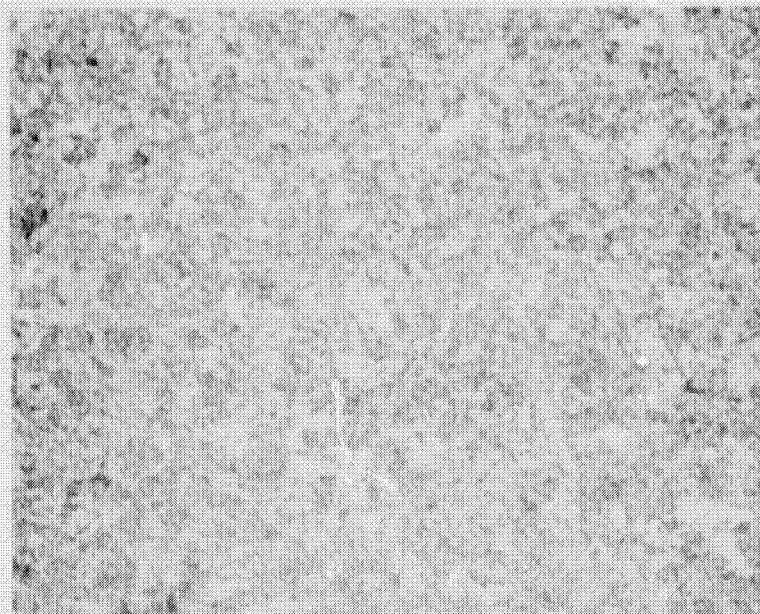
Optical photomicrographs are presented in Figures 10 through 15 to show the case and core microstructure of CBS 600. Microstructure observed in Test Series y is shown in Figures 10, 11, and 12. Core grain size is estimated to be ASTM #7 to 8. It is also noted that fine networks of small carbide particles were found to form along the prior austenite grain boundaries in the case microstructure of Test Series y (Figure 11-(a)). This is clearly shown at higher magnification (Figure 12).

Figure 10. Optical Microstructure of CBS 600, Test Series y.

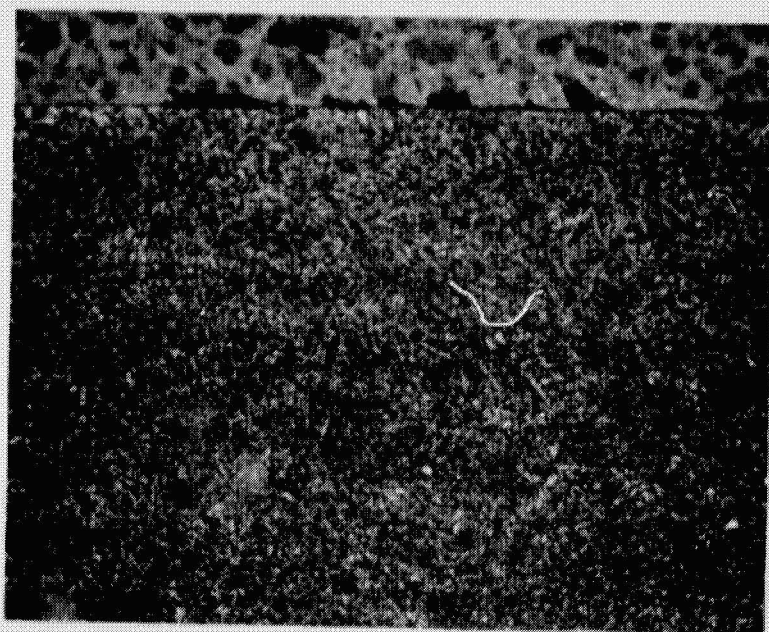
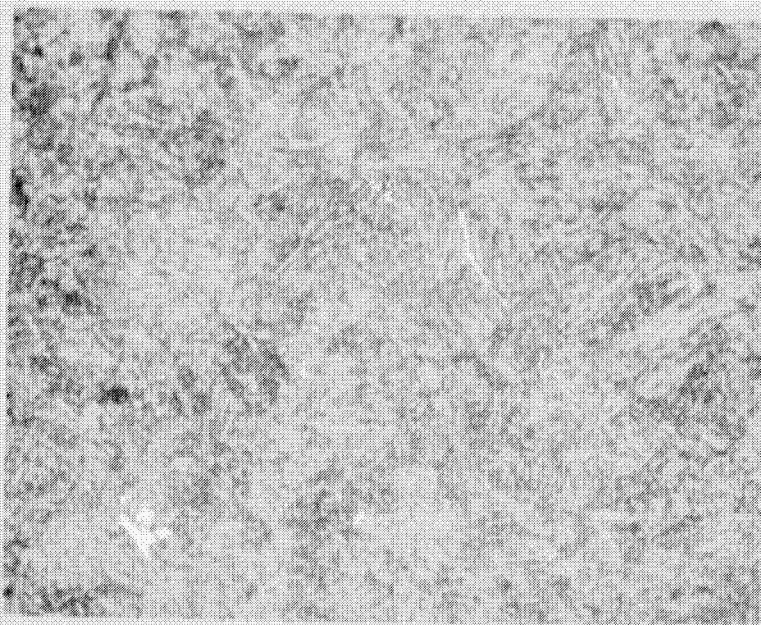
Figure 11. Optical Microstructure of CBS 600, Test Series y.

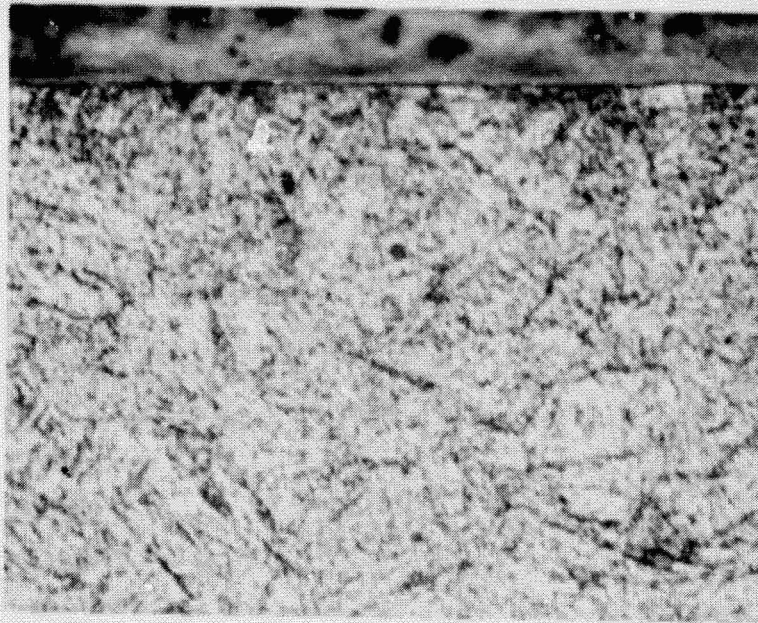
Figure 12. Optical Microstructure of CRS 600, Test Series y, Showing Small Carbides Along Prior Austenite Grain Boundaries.

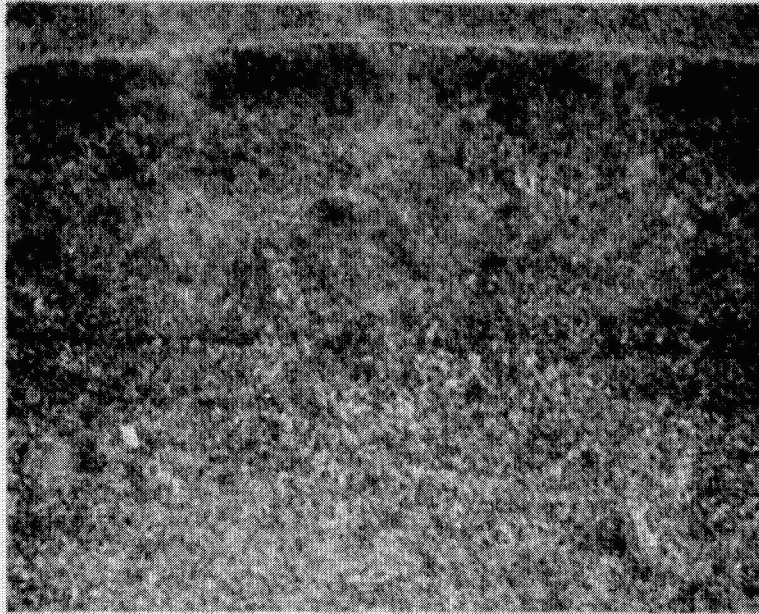
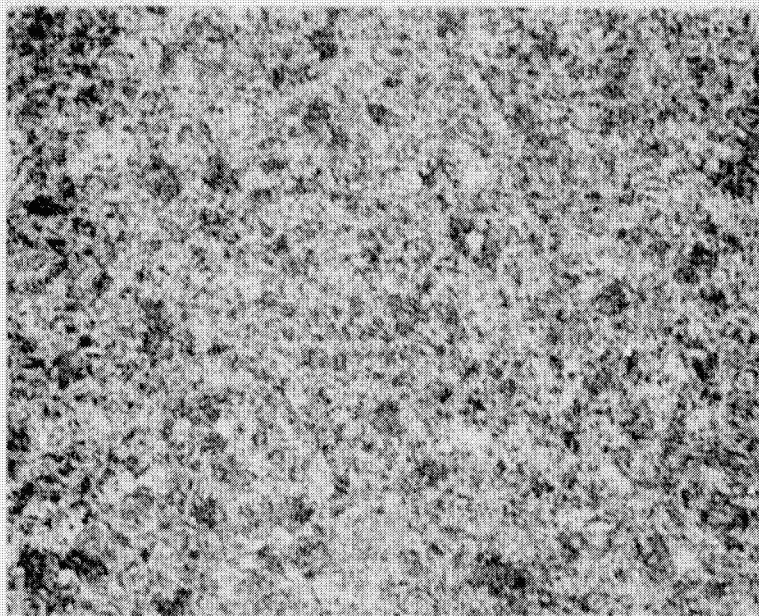
Figure 13. Optical Microstructure of CBS 600, Test Series AD.

No noticeable difference was found in optical microstructure of Test Series AD, AE, and AF, representative microstructure is shown in Figures 13, 14, and 15. The fine carbide network observed in Test Series y was not found in Test Series AD, AE, and AF, indicating carbon potential employed during carburizing cycles was likely to be higher for the case of Test Series y. It should be mentioned here that the microstructure observed in Test Series AD, AE and AF is quite close to the optimum microstructure for bearing and gear applications recommended by the material supplier(11). CBS 600 is known to have almost 100% martensite in the case, and martensite plus ferrite in the core when heat treated under the recommended procedure. White acicular phases in Figures 14-(b) and 15-(b) are indicated to be ferrite.

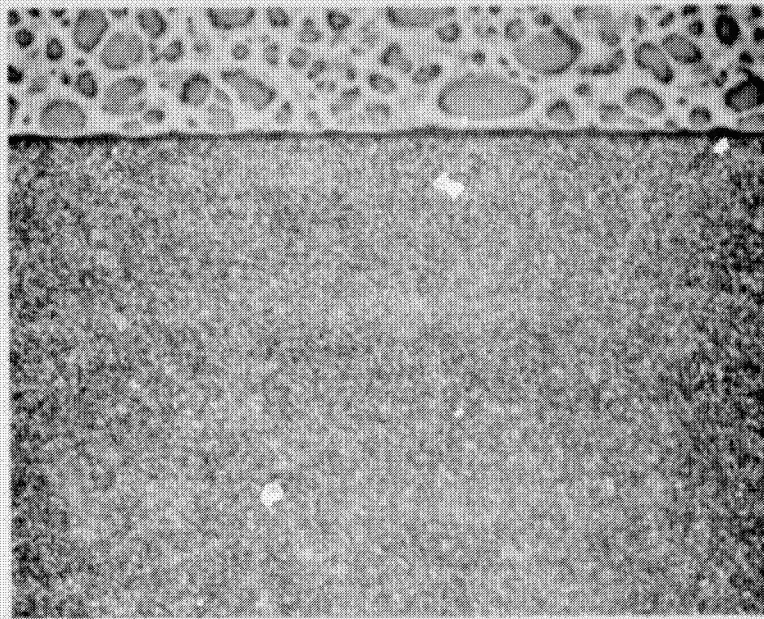
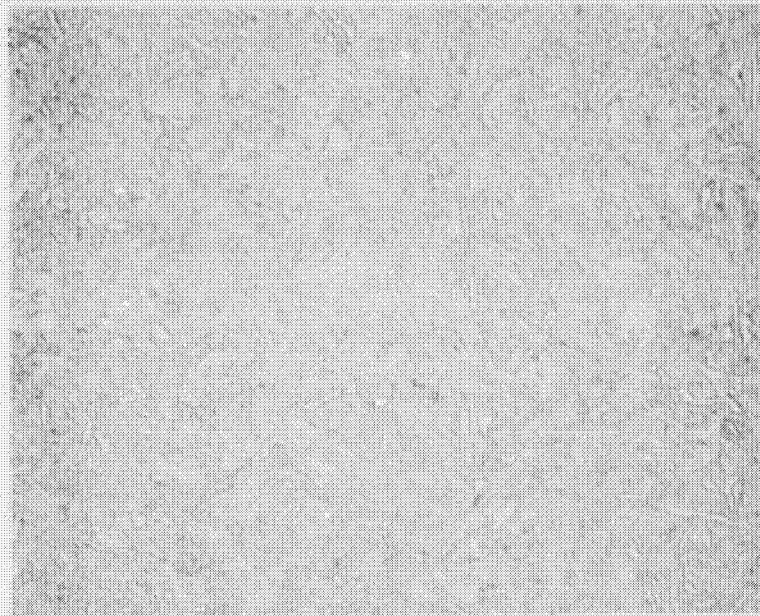
Figure 14. Optical Microstructure of CBS 600, Test Series AE.

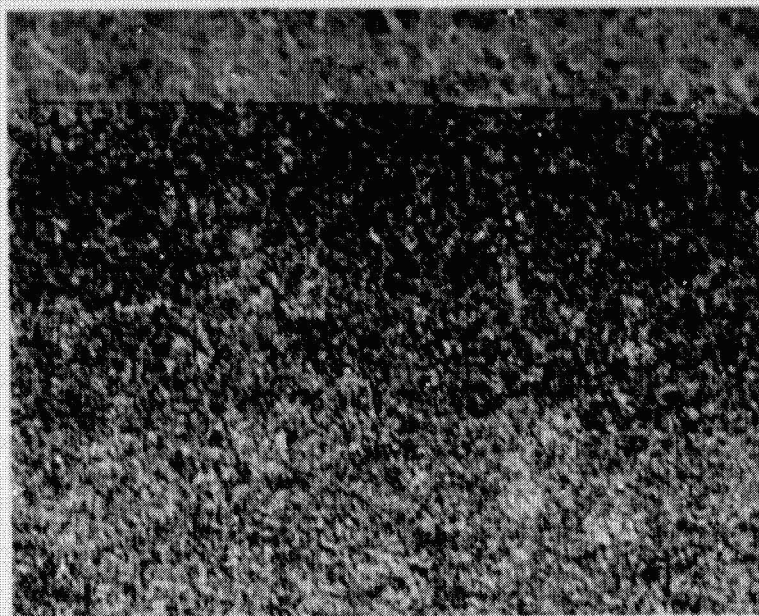
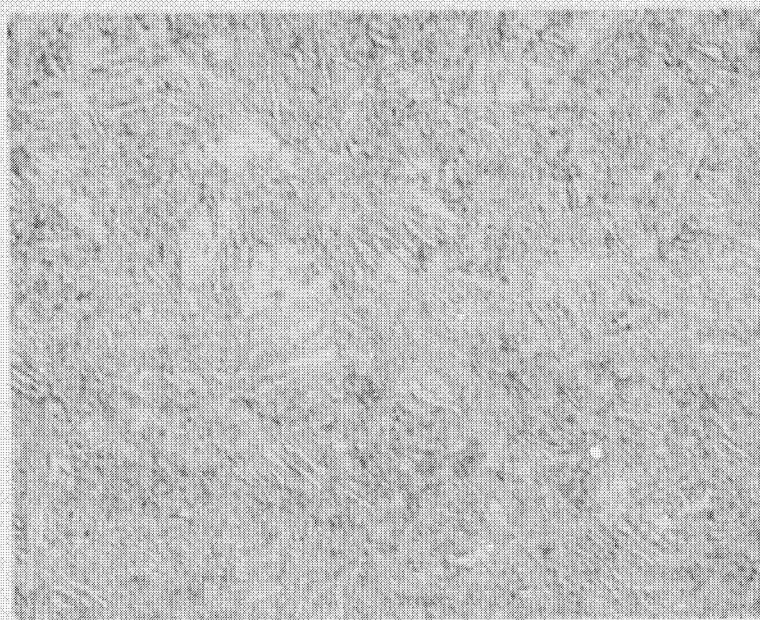
Figure 15. Optical Microstructure of CBS 600, Test Series AF.

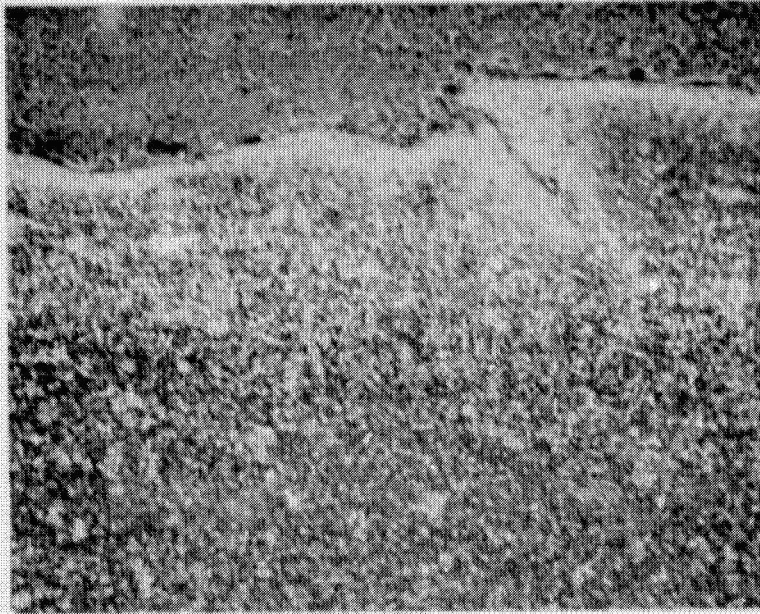
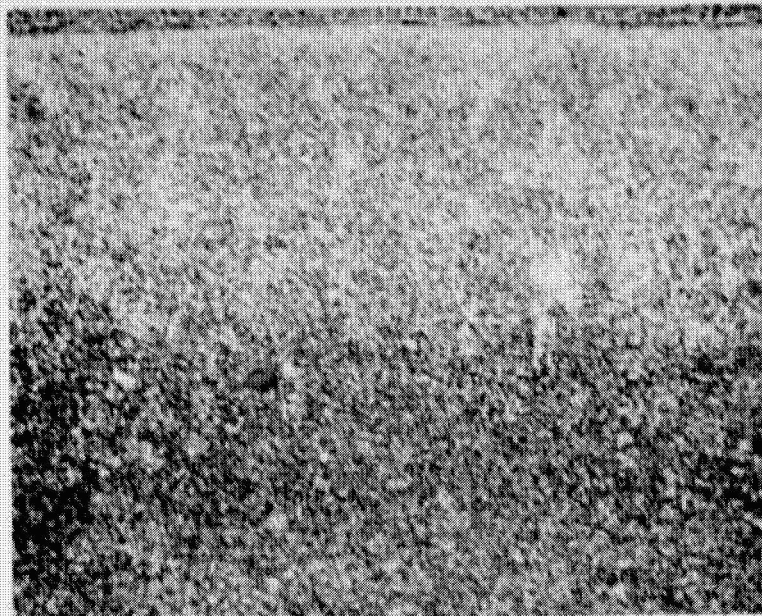
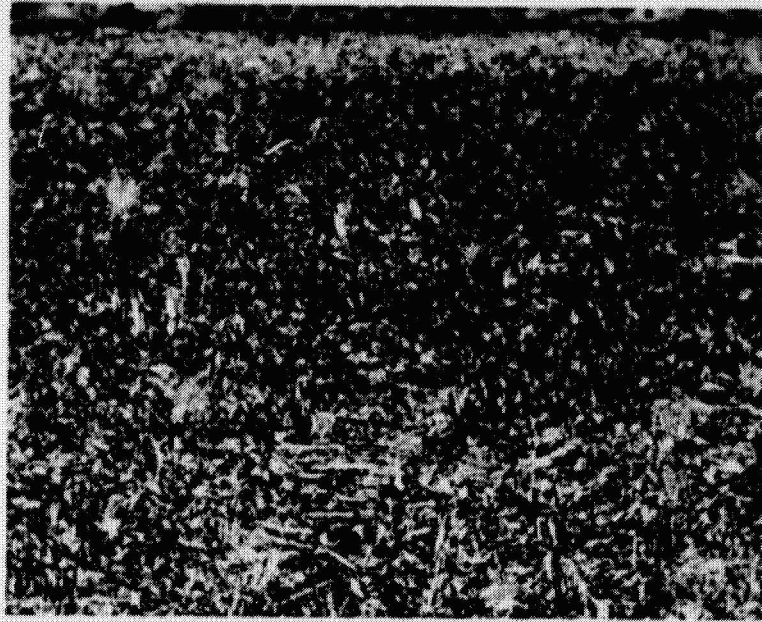
A summary of metallurgical analyses on CBS 1000M and Vasco X-2 is given in Table 13. Optical microstructures of these materials are shown in Figure 18 through 22. It is interesting to note that a microstructural transformation was observed in CBS 1000M due to rolling contact fatigue. This is clearly shown in Figure 21. The microstructural change was observed at about 0.18 mm (0.007 in.) below the surface. It is consistent with the distance from the surface where maximum shear stress exists in the specimen. No microstructural changes were observed in all the other alloys used in the present investigation. The reason for this is unknown. The evidence for high retained austenite found in Vasco X-2 is shown in Figure 22-(a).

Figure 21. Optical Micrographs Showing Fatigue Spalling and Structural Change in CBS 1000M (Test Series AC) After  $6.14 \times 10^6$  Cycles of RCF Testing.

Figure 21. Optical Micrographs Showing Fatigue Spalling and Structural Change in CBS 1000M (Test Series AC) After  $6.14 \times 10^6$  Cycles of RCF Testing (Concluded).

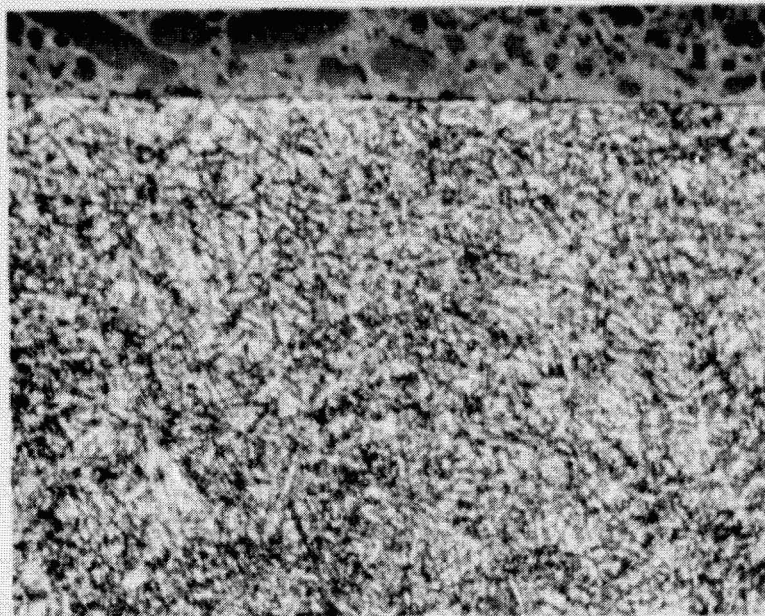
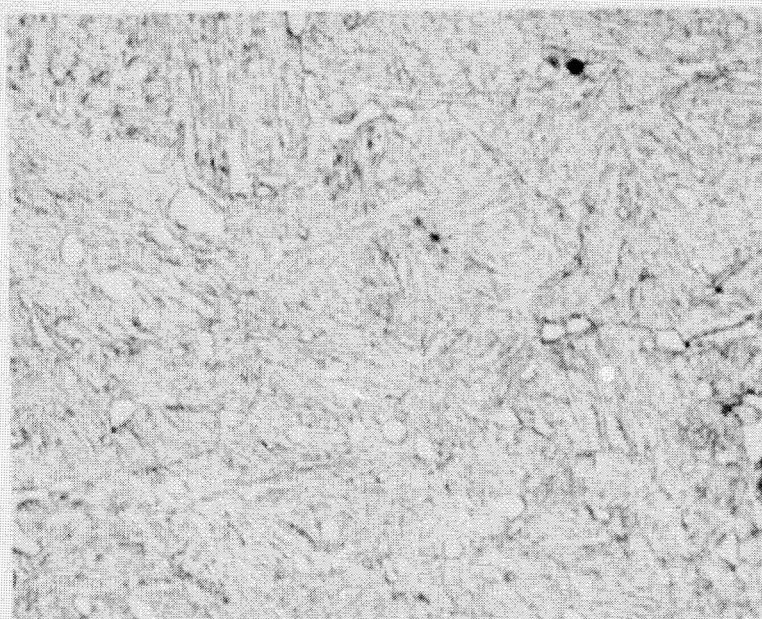
Figure 22. Optical Microstructure of Vasco X-2, Test Series 8.

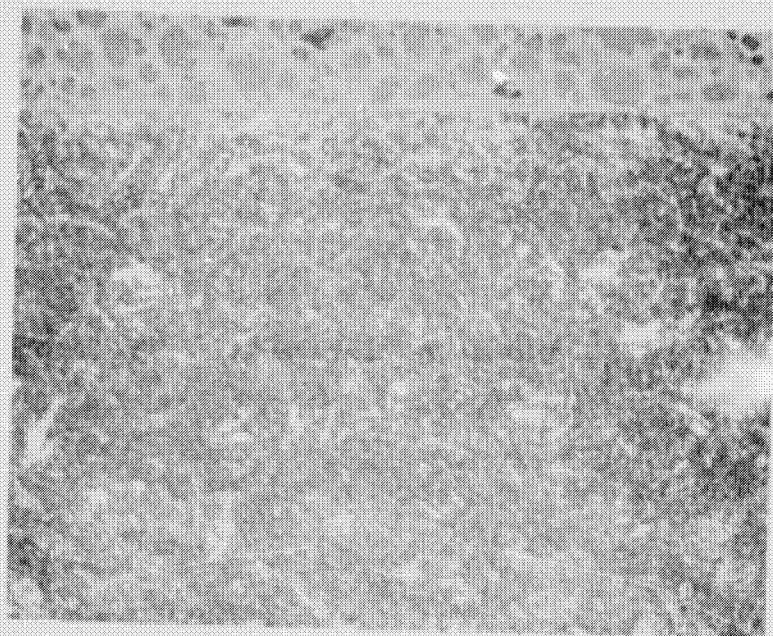
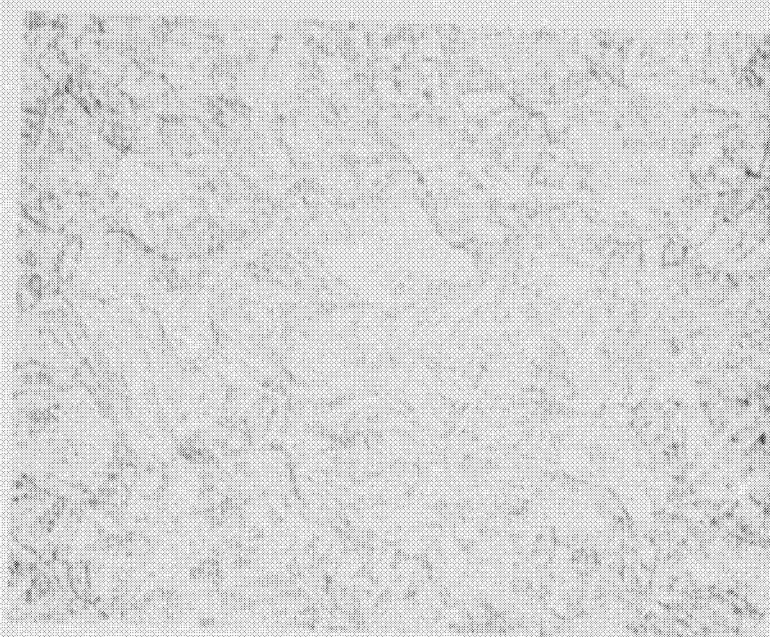
Figures 25, 26, and 27 are optical micrographs showing case and core microstructures of VIM-VAR Super Nitralloy, AM Nitralloy 135 and VAR Nitralloy N, respectively. Delineated formation of nitrides, along grain boundaries, are evident in nitrided case structures of the alloys investigated. The preferential formation of nitrides is, in general, a common phenomenon in nitriding alloys.

Figure 25. Optical Microstructure of Super Nitralloy,  
Test Series II.

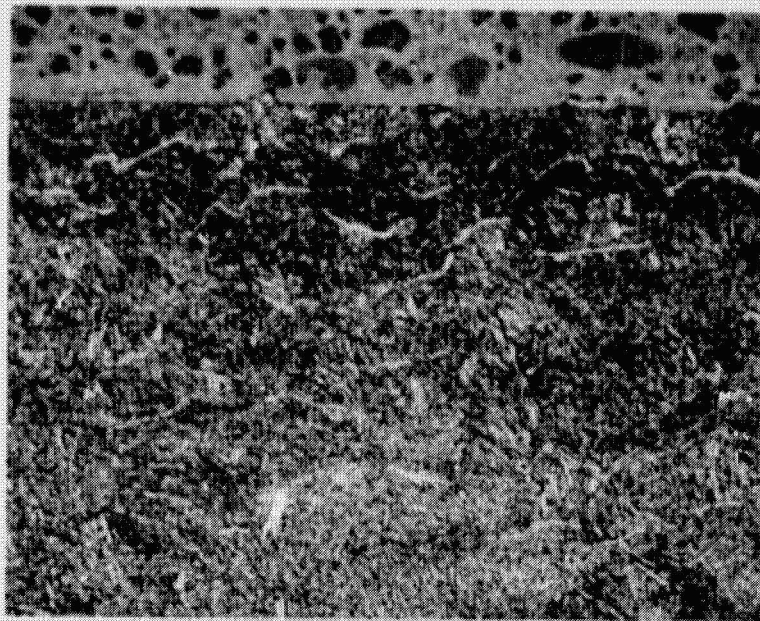
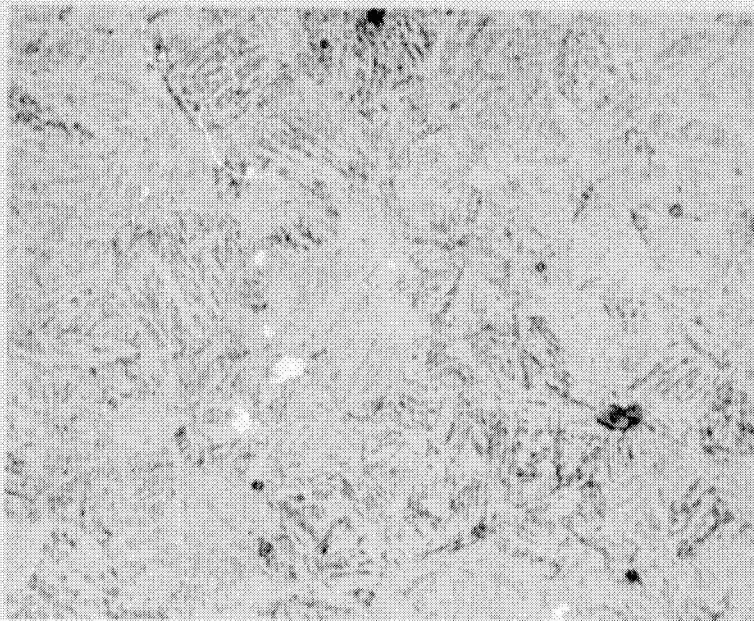
Figure 26. Optical Microstructure of Nitralloy 135,  
Test Series v.

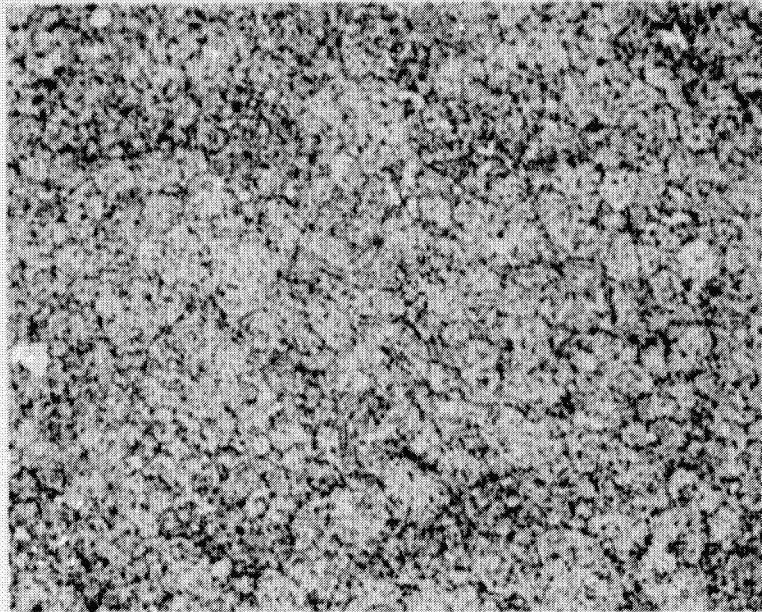
Moderate size carbide particles and fine grains observed in Vasco Matrix II are shown in an optical micrograph (Figure 30). Optical microstructures of AISI W-1, AISI O-2, and AISI S-2 are shown in Figures 31, 32, and 33 respectively. A relatively high density of inclusions was found in AISI S-2. Poor rolling contact fatigue test results of AISI S-2 may be mainly due to the inclusions found in the microstructure. Hardness and the amount of retained austenite are described in Table 21. Relatively high amount of retained austenite, 6.6% and 9.6% respectively, was found in AISI W-1 and AISI O-2. This may account for the longer lives observed in these alloy than

Figure 30. Optical Microstructure of Vasco Matrix II,  
Test Series w.

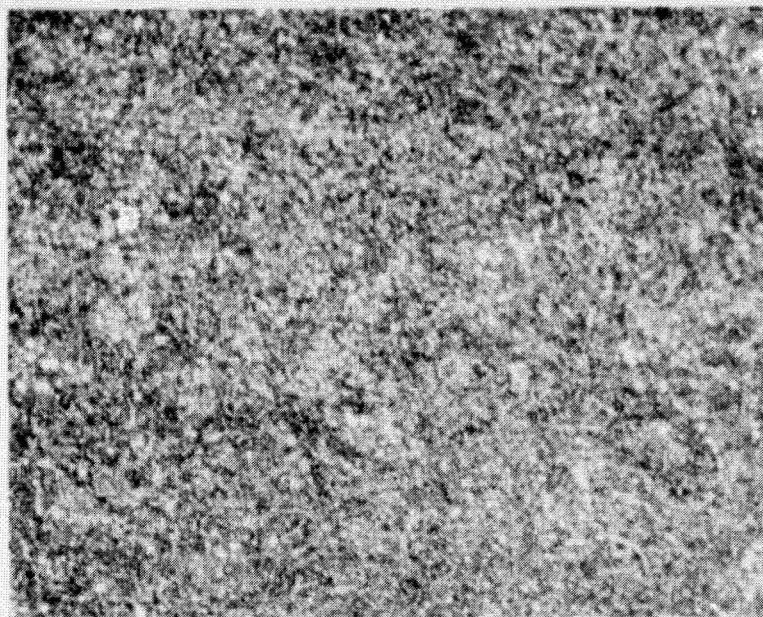
Figure 31. Optical Microstructure of AlAl W-1, Test Series a.

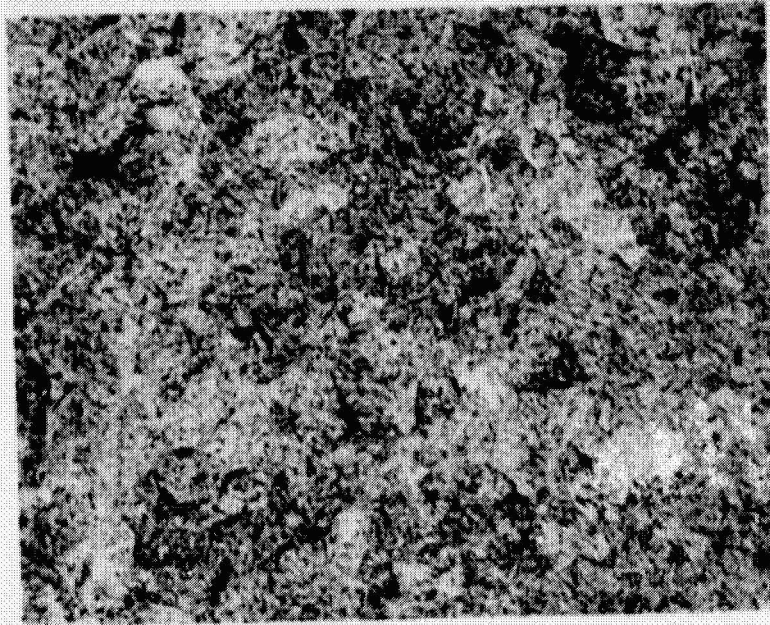
Figure 32. Optical Microstructure of Al-10-2, Test Series B.

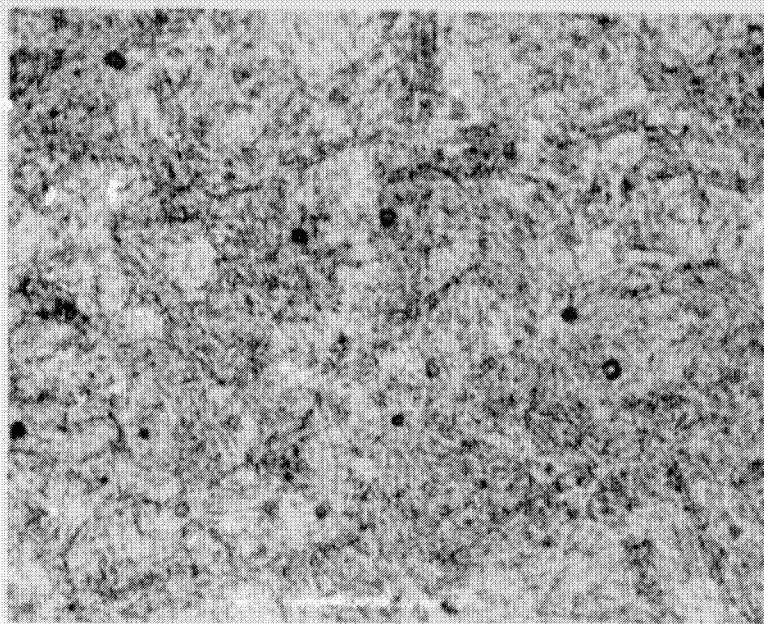
Figure 33. Optical Microstructure of AISI S-2, Test Series  $\gamma$ .
